The Cole Course Protractor - Building of Whisker Crystals through Interaction of Copper Alloy and Cellulose Nitrate. Or: How to Conserve a Self-Destructing Composite Object?

Extract from the Bachelors Thesis at the University of Applied Sciences Berlin, 2018.

Lisa Maria Schubertan*

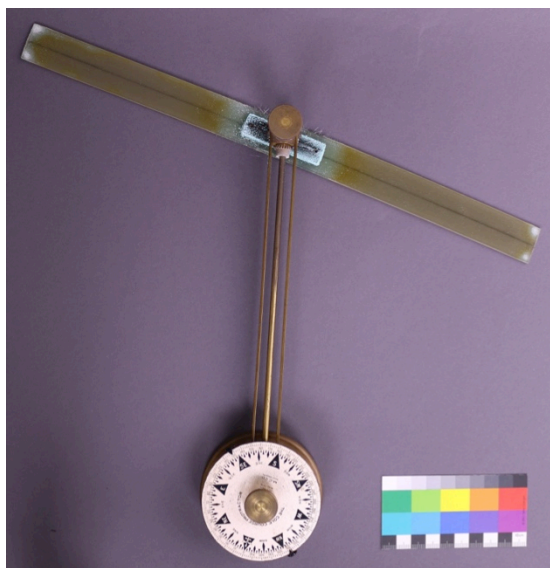
The object before treatment (picture taken by the author, 09/2017).

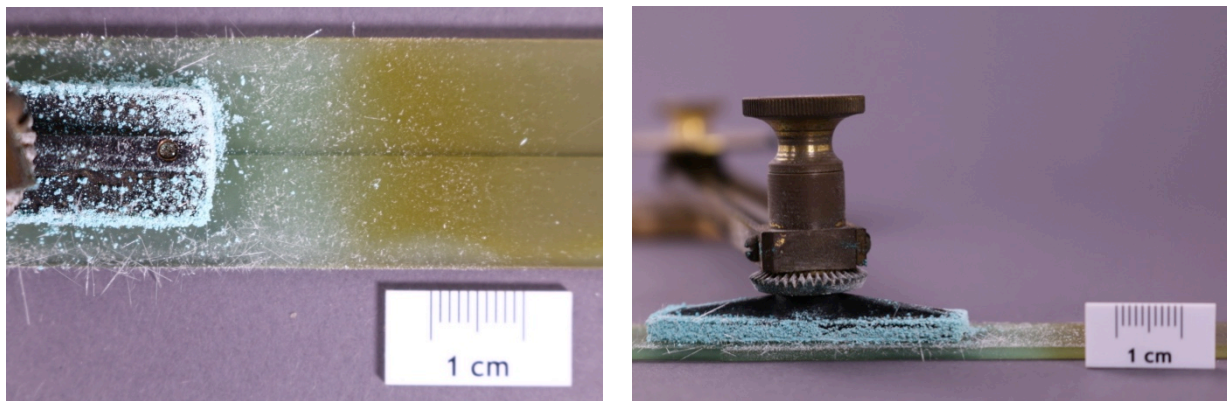
As a means for drawing courses of ships onto maps, the Protractor was produced in the 1920ies in Bryantville, Massachusetts (USA). It combines a compass with a ruler element to help find the direction of a chosen course on a map quickly and to be able to draw them at the same time using only one instrument. Its inventor John F. Cole patented this first version of the “Cole Course Protractor” in 1907 and a second, more flexible one in 1919. Nonetheless, both were fastly replaced by more efficient instruments and represent a rarity in nautical collections. The Protractor here treated had been acquired in 1989 by the German Technical Museum of Berlin and did not show signs of ageing until 2017, where it began to fail dramatically. Not only did the ruler elements’ colour change rapidly, also fine transparent needle-shaped crystals formed on its outer rims.

Details of degradation phenomena on the object (pictures taken by the author, 09/2017).

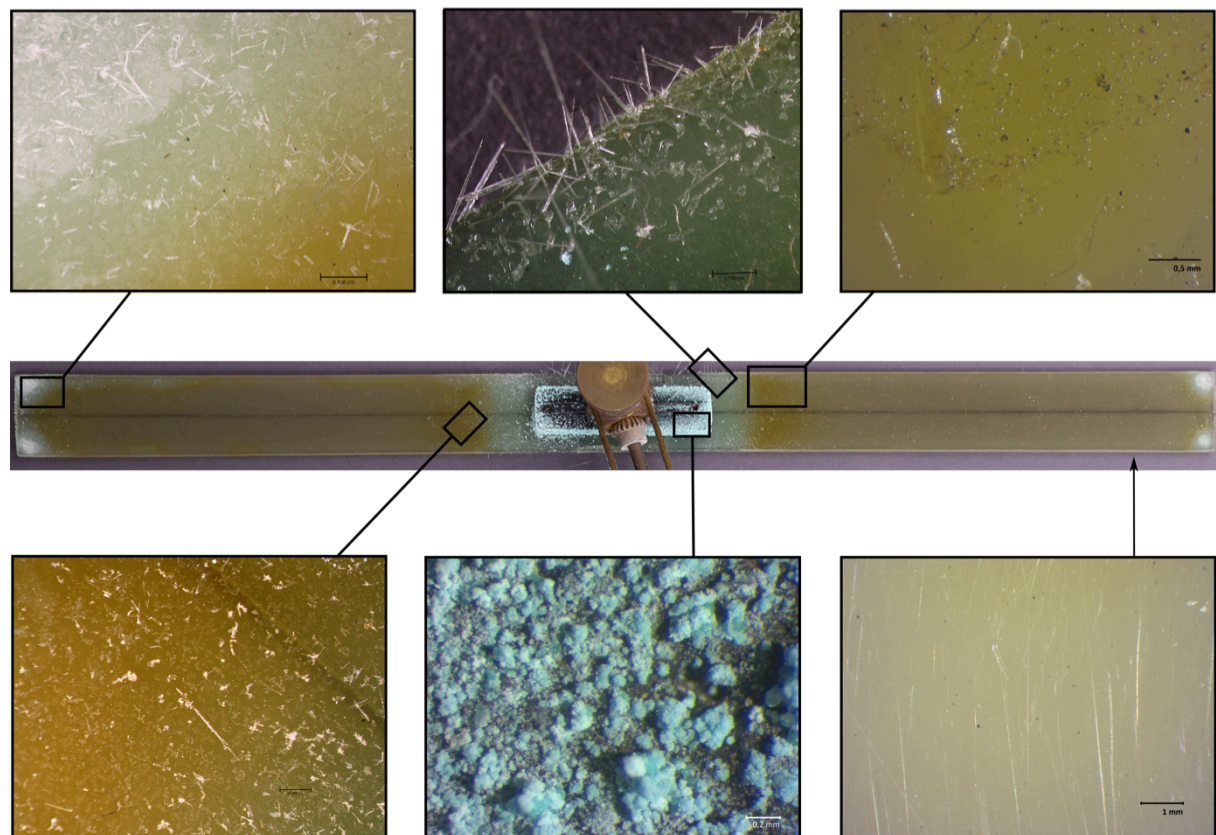
Microscopic views of degradation phenomena of the Protractor (pictures taken by the author, 10/2017), up left to down left:

- 1) Opaque, discoloured, yellowed and uneven surface of the plastic with crystalline particles.
- 2) Needle-shaped crystals and uneven, inhomogeneous surface with transparent, fluid particles.
- 3) Oily brown-yellow stain on the plastic's surface of unknown provenience.
- 4) (Center) Course Protractor, detail with location of the microscopic photographs.
- 5) Partially elevated yellowing of the cellulose nitrate in vicinity to the blue-green discoloured areas.
- 6) Corrosion products on the surface of the metal connecting piece.
- 7) Parallel, very fine scratches on the downside of the ruler.

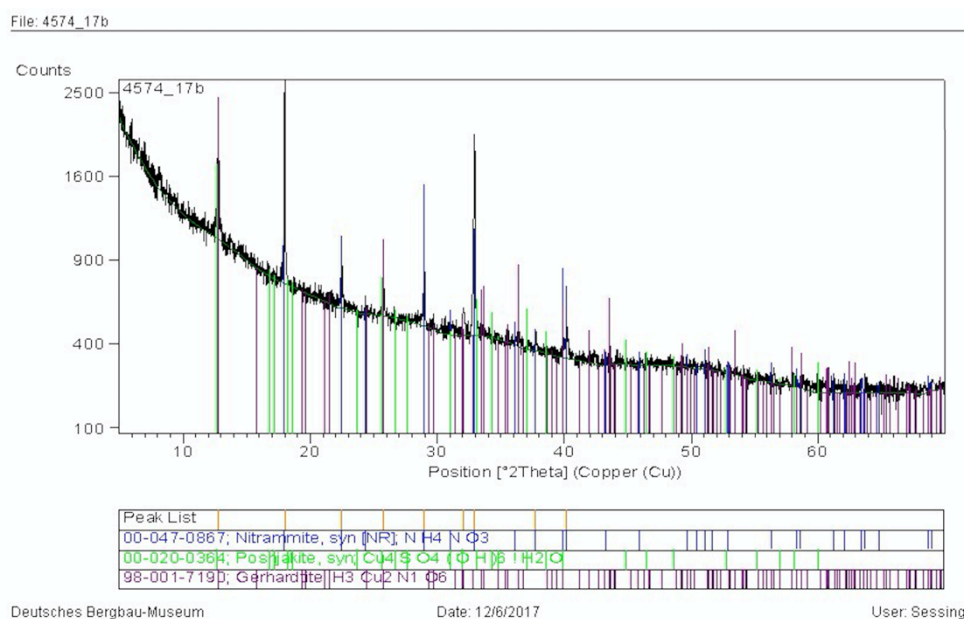
An XRD (x-ray diffraction) analysis of the needle shaped degradation products on the outer rims and edges of the ruler identified them as composed by copper nitrate, copper sulphate and ammonium nitrate¹.

XRD graph of the needle-shaped crystals (taken at the Deutsches Bergbau-Museum Bochum).

Thus the conclusion was drawn that an interaction between the metal and the plastic part had taken place. To understand how the two materials could react chemically with each other, both materials were studied regarding their production and degradation processes.

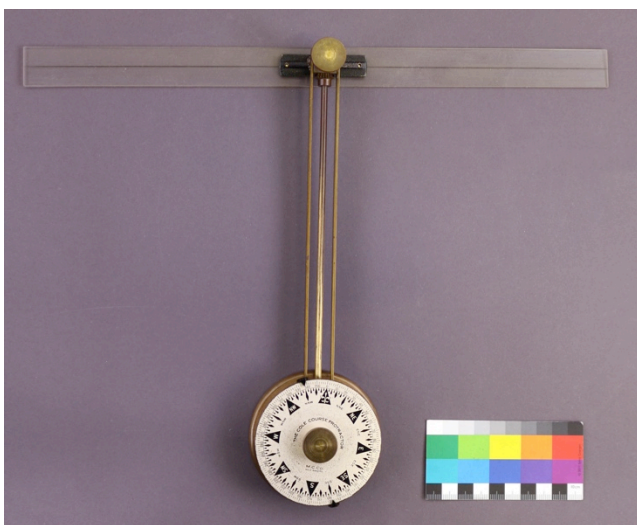
Object (frontside) after treatment, including replacement ruler (picture taken by the author, 03/2018).

The object, as part of the permanent exhibition of the Deutsches Technikmuseum Berlin, was supposed to return to its place in the vitrine. Therefore it needed a replacement for the plastic part to keep its function understandable to the museum visitors. This was created in Plexiglas, adding the central line through milling and colouring with a pencil. The replacement then was screwed into the metal connecting piece with two new brass screws. Its transparent and modern appearance in contrast to the rest of the object was diminished by a slight yellowing of the plastic applying several layers of shellac onto its bottom side with a brush.

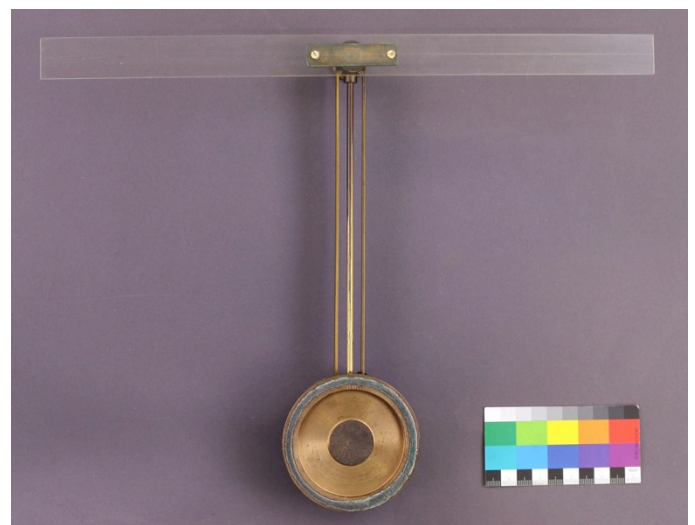
Object (rearside) after treatment (picture taken by the author, 03/2018).

Even though the museum climate is adequate for metals (humidity levels at around 40 % rH), the metal parts were conserved by applying a layer of microcrystalline wax to protect them from possible contact with bare hands during handling.
