The Cole Course Protractor - Building of Whisker Crystals through Interaction of Copper Alloy and Cellulose Nitrate. Or: How to Conserve a Self-Destructing Composite Object?

Extract from the Bachelors Thesis at the University of Applied Sciences Berlin, 2018.

Lisa Maria Schubertan*

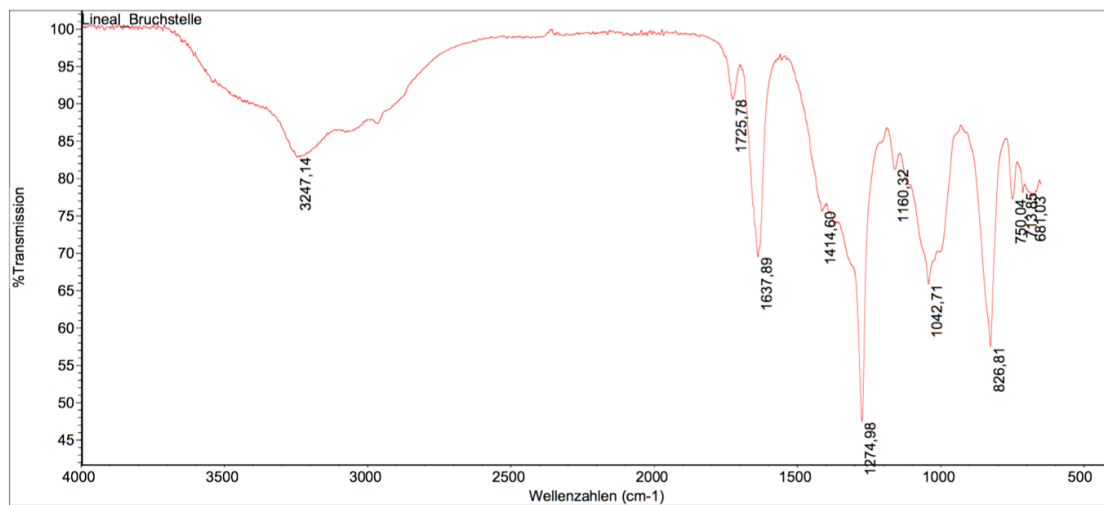
The time of production, the appearance and the degradation phenomena of the plastic part gave indication on the material to be possibly either cellulose acetate or cellulose nitrate. An FTIR (Fourier-transform infrared spectroscopy) analyses confirmed that it is cellulose nitrate, but unfortunately it did not help identify a plasticiser nor the nature of the crystals.

FTIR spectrum of the ruler (taken at the University of Applied Sciences Berlin).

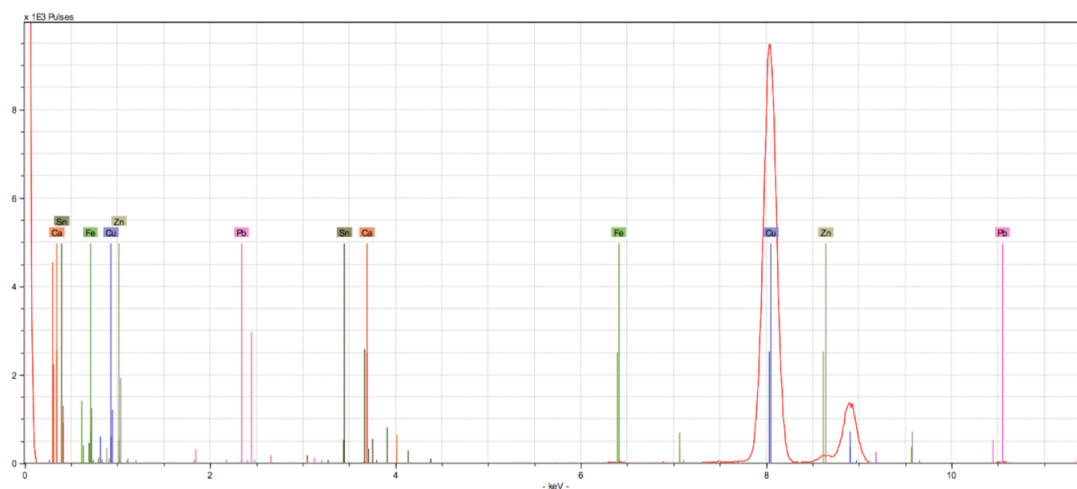
Through an XRF (x-ray fluorescence spectroscopy), the metal parts could be specified as an alloy of mostly copper and zinc.

XRF-graph of the metal connection part to the ruler element (taken at the University of Applied University Berlin).
